CASE STUDY

Bus Duct Monitoring in a Colocation Facility

United Kingdom, Greater London

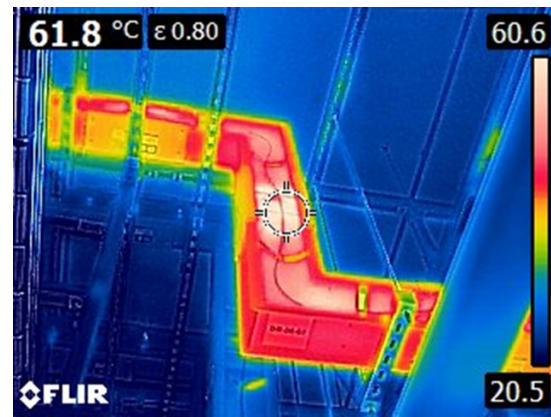
Above: Thermal image of cable installed along bus duct
Below: Sensor cable fitted on bus duct

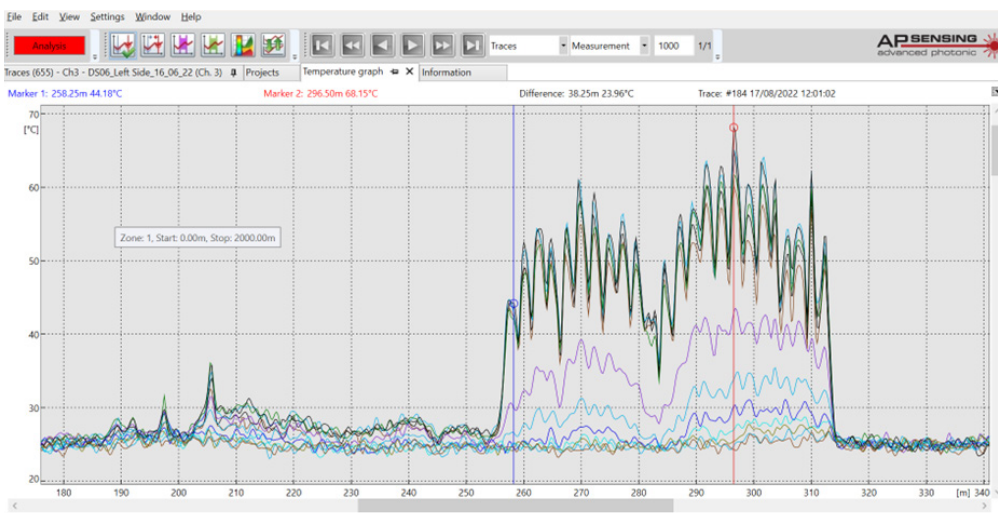
Temperature profile of entire bus duct
