## CASE STUDY

# Continuous Bus Duct Monitoring for Data Centers

USA / Frankfurt, Germany

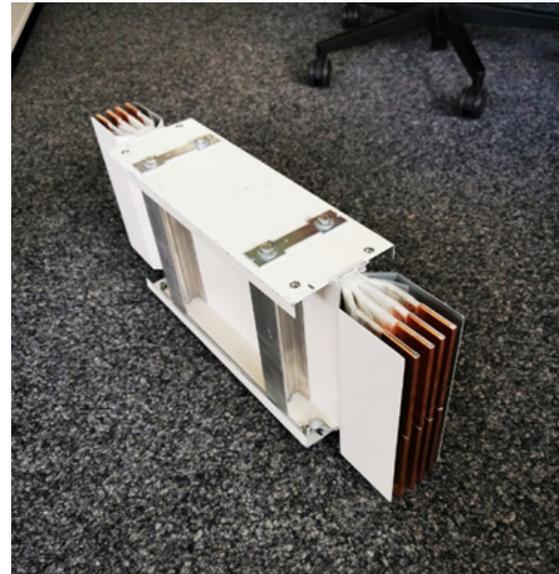
*Schneider 2000A busway – sensor cable route planning and retrofitting by STS Group*

While the cloud facility was in full operation, the fiber optic sensor cable was carefully fitted along the required 2000A ampacity busway using a fastening solution specially developed for bus ducts. This live production data center has busway infrastructure spanning across two levels of the building and crossing more than a dozen separate rooms and corridors and at a typical height of 3 m above the floor level.

Following discussion with Facility Management, STS Group assisted in the CBTM solution. The sensor cable routing is in direct physical contact with the busway housing, with the DTS continuously measuring the busway housing temperature along each feeder, elbow, tee and busway joint.

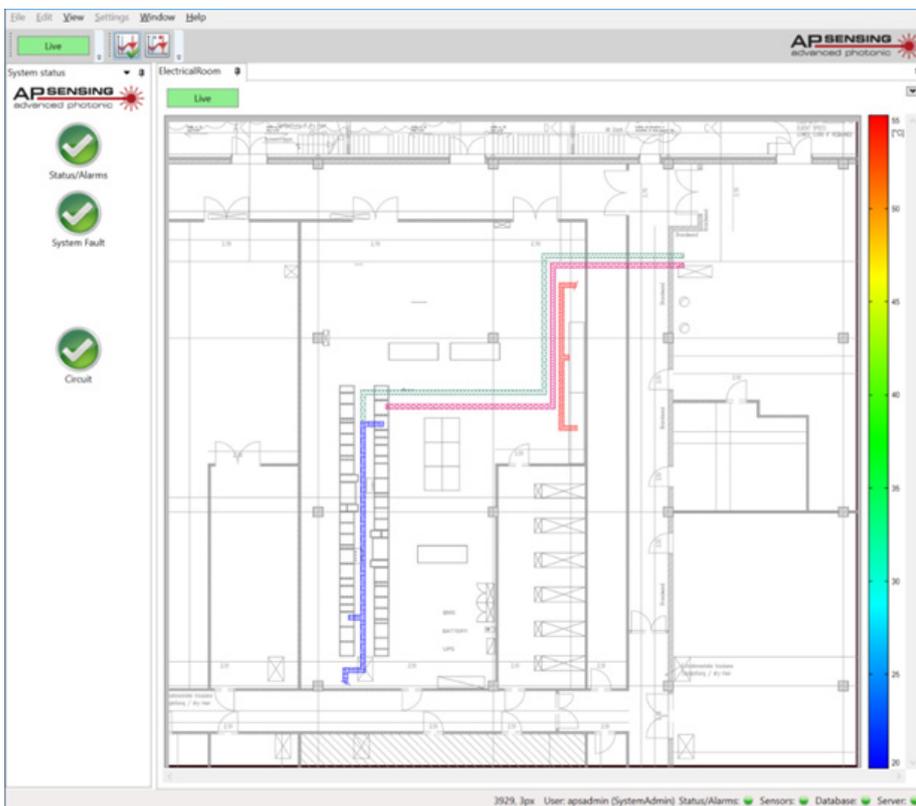
*AP Sensing’s SmartVision AssetView*

SmartVision AssetViewer software provides a visual overview of the entire infrastructure and any points of concern. Having been alerted of a hotspot alarm, the on-site maintenance engineer is able to utilize SmartVision to carry out a local investigation and rapid, detailed assessment without needing physical access to the secure location.
