Optical Fault Location and Temperature Monitoring of a 220 kV Power Cable

Norway/Denmark

Project Overview

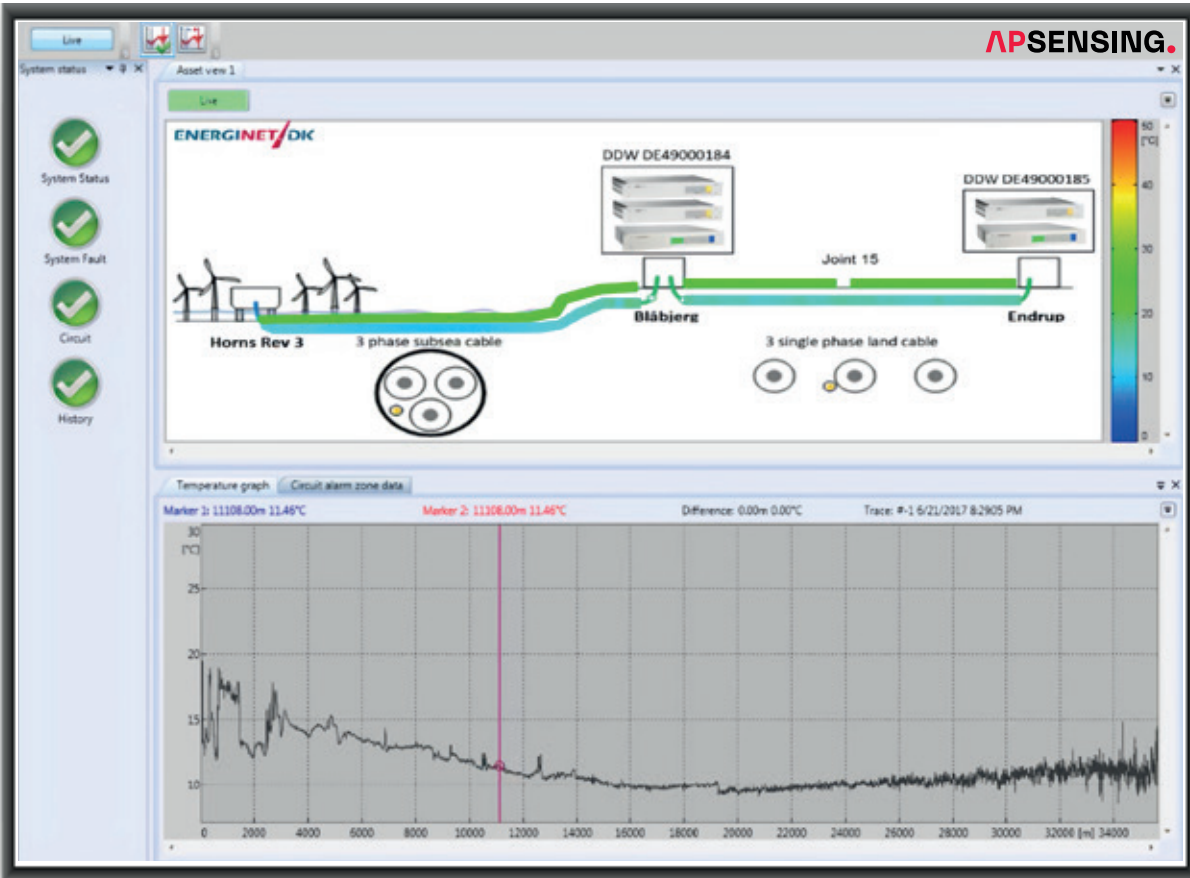
Figure 1: SmartVision graphical user interface

The DAS system is configured to monitor the power cable in real time, visualize the acoustic energy over time/distance in waterfall plots, and store the measured data. The system is additionally configured to alarm fault events and visualize the alarms in SmartVision.

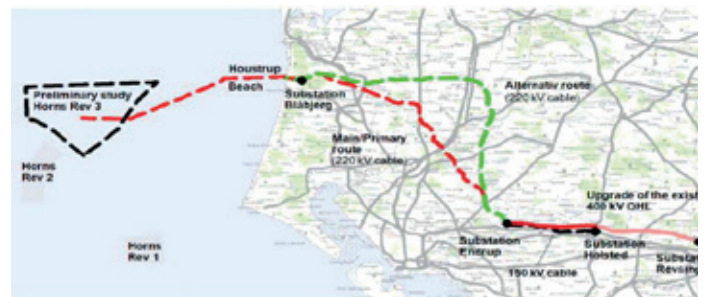
Figure 2: Off- and onshore power cable routing

Horns Rev 3 is Denmark's 3rd offshore wind farm. AP Sensing's solutions monitor the offshore transformer platform itself as well as a 220 kV offshore power cable of 36 km length from the platform to the transition joint located onshore and then to the substation Blåbjerg. Additionally, a 45 km long, 220 kV underground land cable from the substations Blåbjerg to Endrup is monitored.

Loose tube fiber optical cables with 4 x 12 G 652 D single-mode fibers and 1 x 6 OM 3 multi-mode fibers were installed. At the subsea section, the sensor cable is located inside the three phase subsea cable, which is buried 1 m below the seabed. At the land section, the sensor cable is located in a Ø 40 tube close to the center single-phase cable, which is buried 1.4 m below the surface.

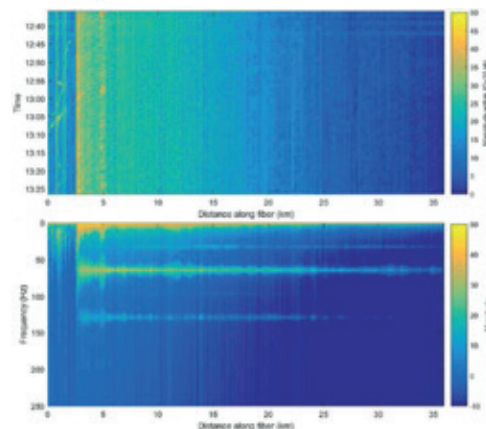
Figure 3: SmartVision

APSensing’s proprietary asset visualization software, SmartVision, provides multiple operators at multiple locations with a graphic overview of all temperature and acoustic information for their critical infrastructures. The main user interface for SmartVision™ is located at the Endrup substation.

The software tool collects the temperature data in real time from the two DTS devices and the alarms from the 3 DAS devices, providing the user with a combined overview of both systems.

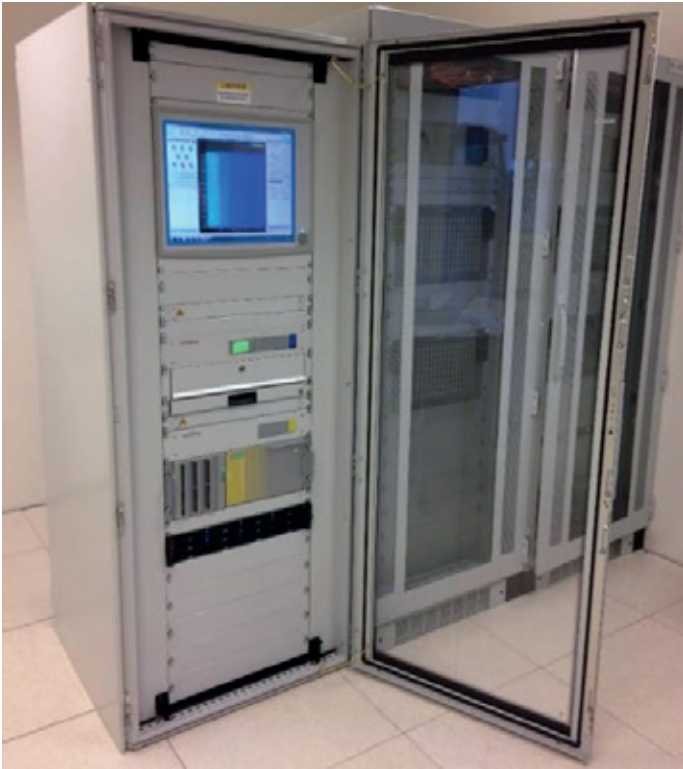
Figure 4: Fully integrated rack solution with DTS, DAS and SmartVision in the control room

The optical fault location system consists of three DAS systems, including a single channel DAS interrogator, a DAS data acquisition unit, and a storage unit each. Two DAS units are located in Blåbjerg and one in Endrup. All have a 40 km measurement range. The temperature monitoring system consists of two DTS units. The first is in Blåbjerg with two channels and a 50 km measurement range. The other DTS unit is located in Endrup with four channels and a 30 km measurement range. The free channels are allocated for upcoming projects.

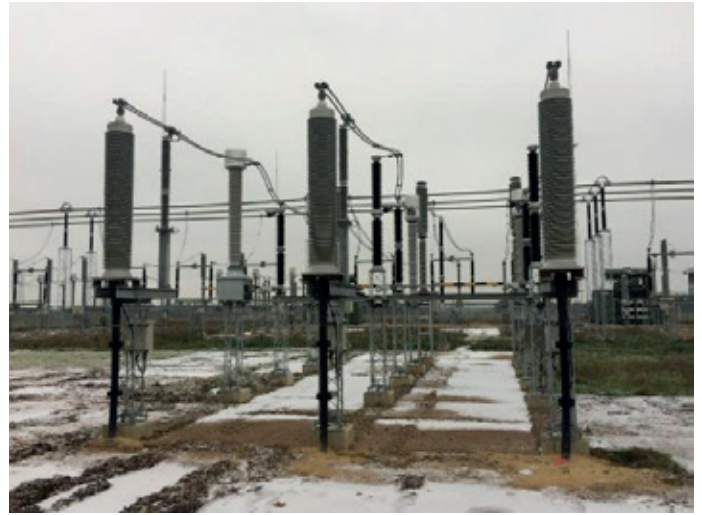
Figure 5: Installations at project site

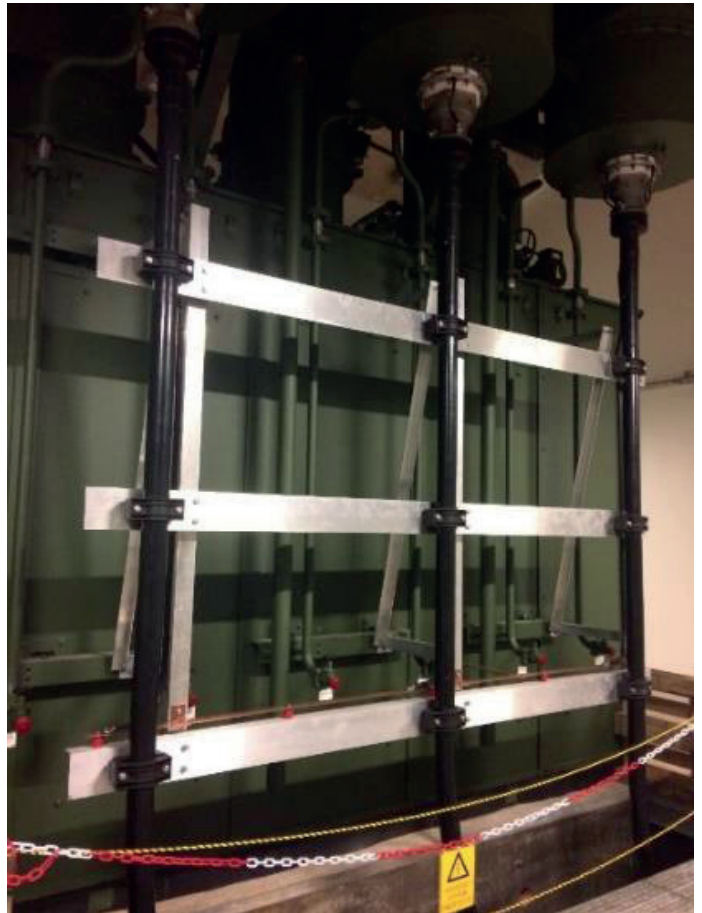
Figure 6: Installations at project site
