ADVANCED MONITORING TECHNOLOGY FOR DISTRICT HEATING PIPELINES USING FIBER OPTIC CABLE

Sukyong Song¹, Jooyong Kim²

¹ AP Technologies Inc, 1213, 21, Yangpyeong-ro 22-gil, Yeoungdeungpo-gu, 150-105, Seoul, Korea

² KDHC, 781, Yangjae-daero, Gangnam-gu, Seoul 135-220, Korea

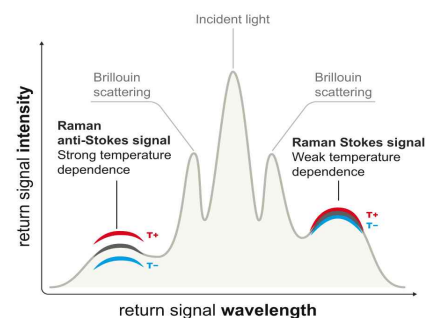
Figure 1. Distribution of laser reflection scattered light

The backscattered light is spread across a range of wavelengths. Some of these wavelengths (Stokes and anti-Stokes scattering) [2] are affected by temperature changes while others are immune. Their ratio depends on the temperature (which can practically be exploited for the measurement of temperature).

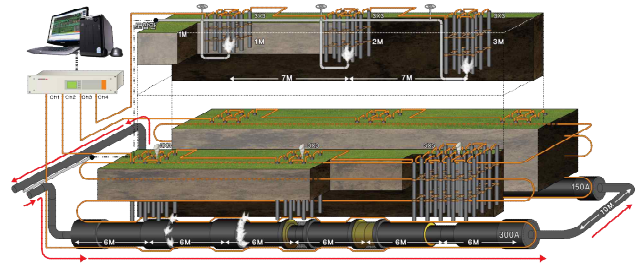
We bury two heat transfer pipes 1.5 m under the ground while diameter of one pipe is of 300A³ and the other 150A⁴ just same as the typical structure. To measure the heat source release by damage type, we did similar damage to the connection areas of pipes. Optical sensor cables which were coiled over perforated drainpipe with helical shape of 0.1m installed over the top of the heat transfer pipes vertically to measure and analyze the vertical heat transfer. In order to test detection performance during heat sources release of heat transfer pipe, sensor cable was also installed in depth

with 0.5m, 1m, and 1.5m from the surface along the burial route.

Figure 3. Test setup diagram

The test described above is performed to verify the efficiency of new heat transfer pipe installation and validity of optical sensor cable installed over the existing heat transfer pipe.

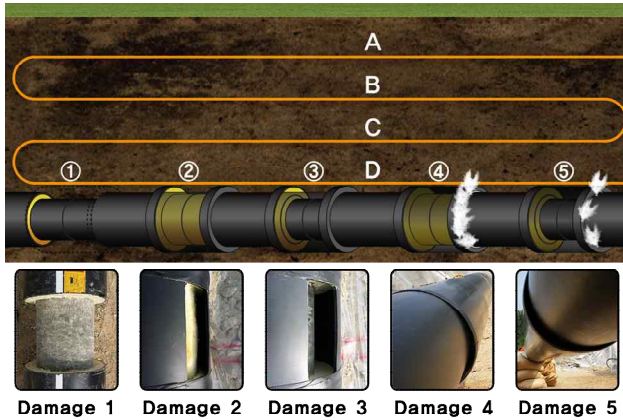
To differentiate the heat quantity of source, it sets 3 different sizes for damages and two for insulation damages.

*Damage on upper area: 280(W) x 110mm(L) cutting

Figure 4. Image and picture of regular damage of heat transfer pipe

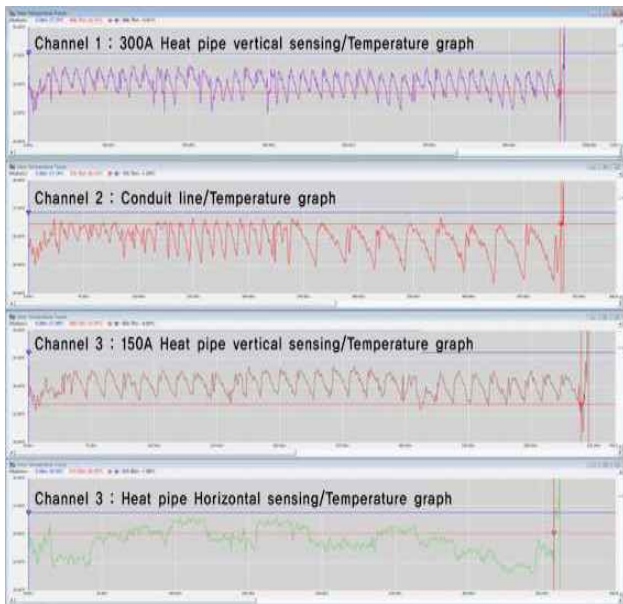
Figure 5. Raw data screen of whole area after installation

As indicated in the feature above, the test result shows that the performance of optical cable sensor is good regardless of horizontal or vertical, and size of heat transfer pipe. The reason why upper 3 graph patterns are different from lower 1 pattern is from installation method. (Upper 3 are installed at 0.1m in perforated pipes in helical shape to do monitoring in triangular wave

while lower 1 is installed on tope of heat transfer pipe in a lineal way to do monitoring in horizontal wave.)

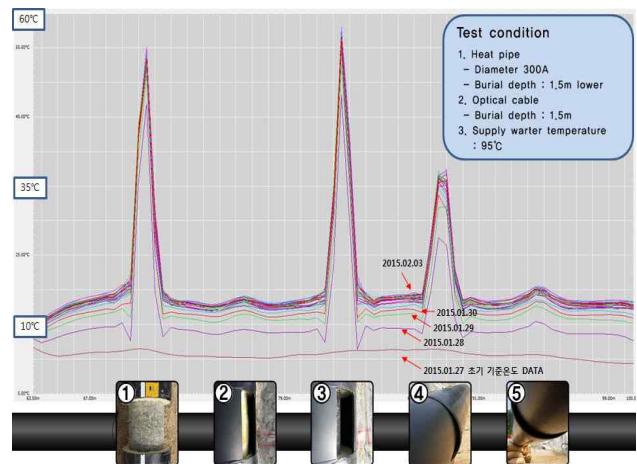
Figure 6. Setting of pipe damage_ temperature trend in time (1 week)

Time consumed to transfer heat depends on the quantity of heat source and distance. It is expected the heat would disperse further as time goes by. However, within less than one day, the significant temperature changes are recorded for each failure mode during the test.

In other words, heat is estimated transferred by conduction not by convection.
