Heat Tracing on Phenol Pipeline

Freeport, Texas, USA

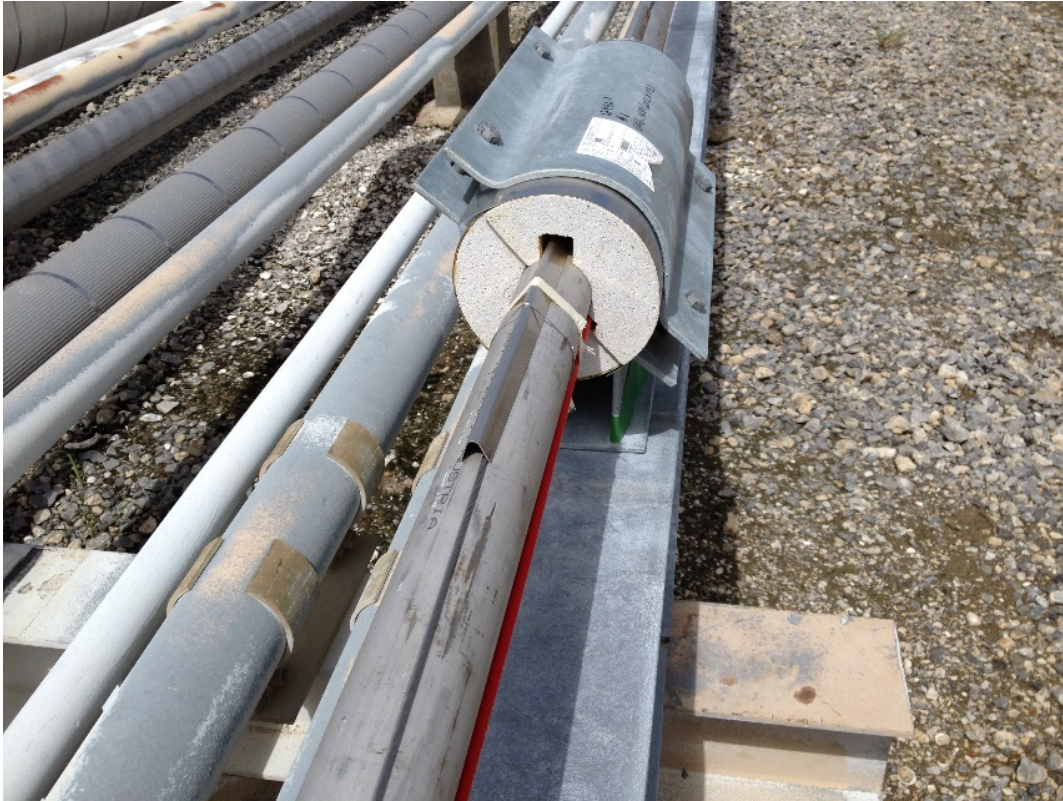
Phenol transport pipelines with heat tracing

A single AP Sensing DTS device was installed to monitor the full 1.2 km phenol pipeline. The DTS unit was securely installed in a remote control room. The fiber optic sensor cable was installed under the pipeline insulation along the full length of the pipeline.
