# Pipeline Monitoring - TPI & Leak Detection

## Romania

### Project Overview

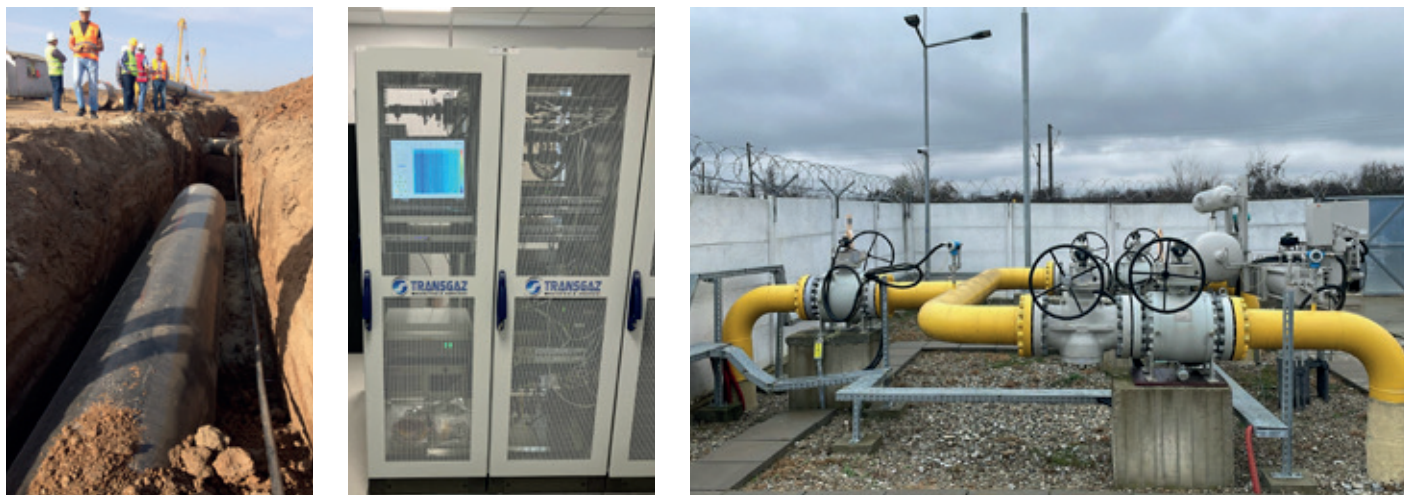
Figure 1: BRUA pipeline with FOC duct during the installation phase and monitoring cabinet located in one of the valve stations

by Adrem. Two separate servers with the main operator interface SmartVision are configured to visualize and send the alarm information to SCADA. Figure 1 illustrates the pipeline and FOC duct during the installation phase and a monitoring cabinet in one of the valve stations.
