Under the Tracks: Detecting Sinkholes with Fiber Optic DAS

Saudi Arabia

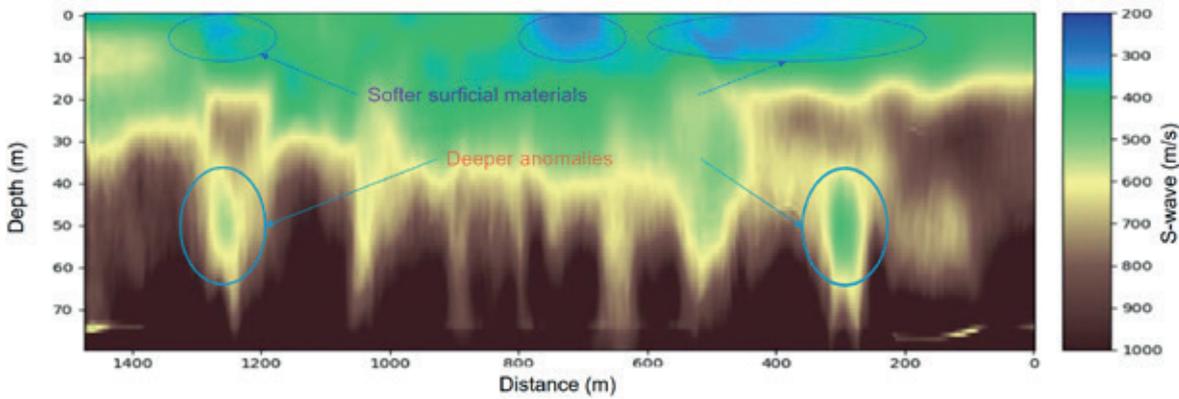
Figure 1: 2D shear wave velocity profile beneath the rail track, derived from DAS data. Colours show the ground stiffness: blue/green indicates softer, slower rock, while brown shows harder, faster formations.

An important component of the monitoring strategy was fiber optic sensing. The team deployed AP Sensing’s high resolution Distributed Acoustic Sensing (DAS) technology across the full 1.5 km rail. The fiber optic cable connected to the DAS system was installed along the rail subgrade to provide continuous, long-distance, and long-term measurements, enabling the detection of ground vibrations and potential void formation, complementing more conventional instrumentation. As a result, the rail line operator was able to maintain operations on a critical commercial routewhile effectively managing sinkhole risks.

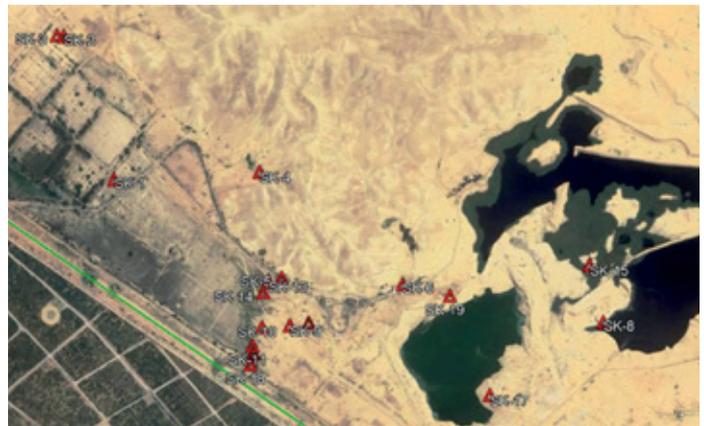
Figure 2: Plan view of the installation

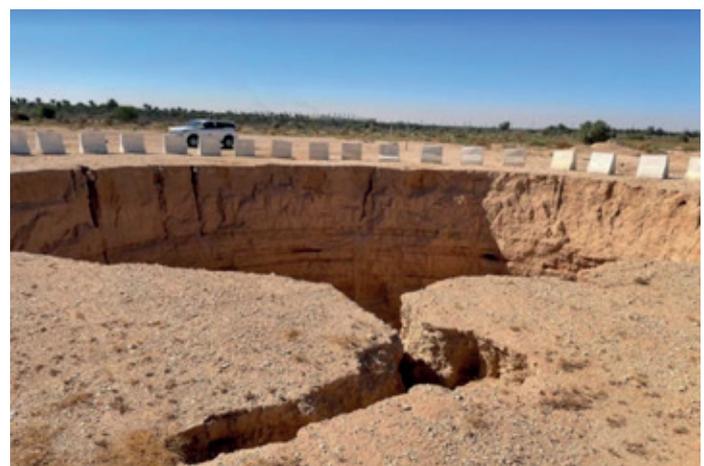
Figure 3: Sinkhole formation along road in Saudi Arabia
