Pipeline Monitoring - TPI & Leak Detection

Romania

BRUA (Bulgaria – Romania – Hungary – Austria) is a strategic 479 km long natural gas transmission corridor allowing Romania to access natural gas transportation routes from the Caspian Sea to Central Europe and facilitating the exploitation of additional gas resources in the Black Sea.

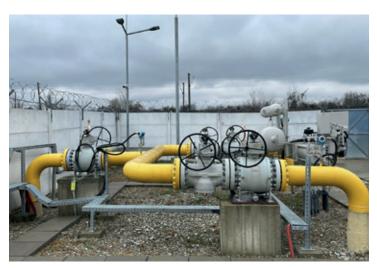
Figure 1: BRUA pipeline with FOC duct during the installation phase and monitoring cabinet located in one of the valve stations

The monitoring solution consists of 10 single channel N5200A DAS instruments with measuring ranges of 50 km and 70 km depending on the distance between the valve stations. Each of the systems is connected to a dedicated single-mode fiber within the FOC, which is installed in a duct and placed at the 2 o'clock position

within a distance of approximately 30 cm from the pipeline wall. All sensing instruments are mounted in standard 19" cabinets which are located in ten substations along the pipeline. Two separate servers with the main operator interface SmartVision are configured to visualize and send the alarm information to SCADA. Figure 1 illustrates the pipeline and FOC duct during the installation phase and a monitoring cabinet in one of the valve stations.

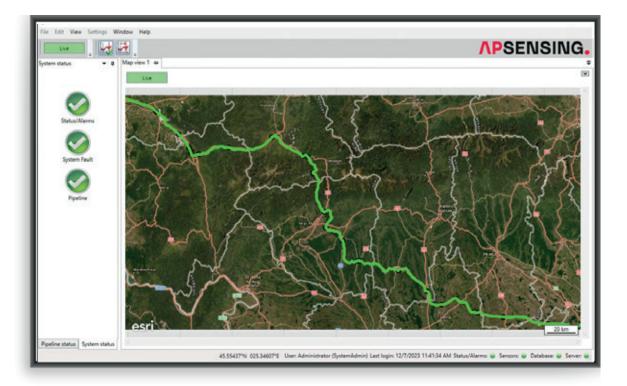
Figure 2: SmartVision interface with a map view of the BRUA pipeline route

The alarm notification is visualized on AP Sensing's monitoring platform SmartVision (see Figure 2) and forwarded to the SCADA system via IEC-60870-5-104 protocol. In the case of TPI, gas leak, or fiber break events, the location is highlighted on the map view of SmartVision, and a notification with the event type, time stamp, duration, fiber/pipeline position, GPS coordinates, and nearest landmark is shown.

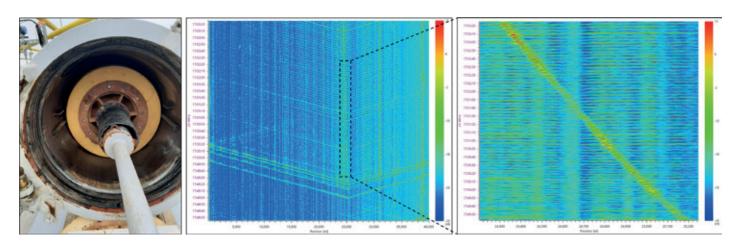
Figure 4: Picture of the cleaning PIG and DAS waterfall diagrams of the moving PIG in one of the pipeline sections

Figure 4 illustrates a scrapper used prior to the instrumented PIG campaign. The waterfall diagram shows the signal imprint of the PIG, moving at approx. 10-12 km/h and generating pressure waves travelling at a velocity of 430-450 m/s.

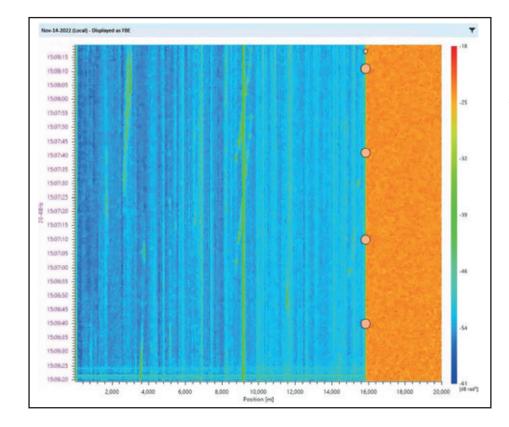
Figure 5: In case of a fiber break, a notification shows up on the DAS waterfall diagram

localization accuracy to approximately the gauge length of the 70 km system. An example of a fiber break encountered during the commissioning phase is shown in Figure 5. It is worth mentioning that the DAS system still offers continuous monitoring of the asset until the fiber break location.
