Bus Duct Temperature Monitoring in a Hyperscale Facility

United Kingdom / United States of America

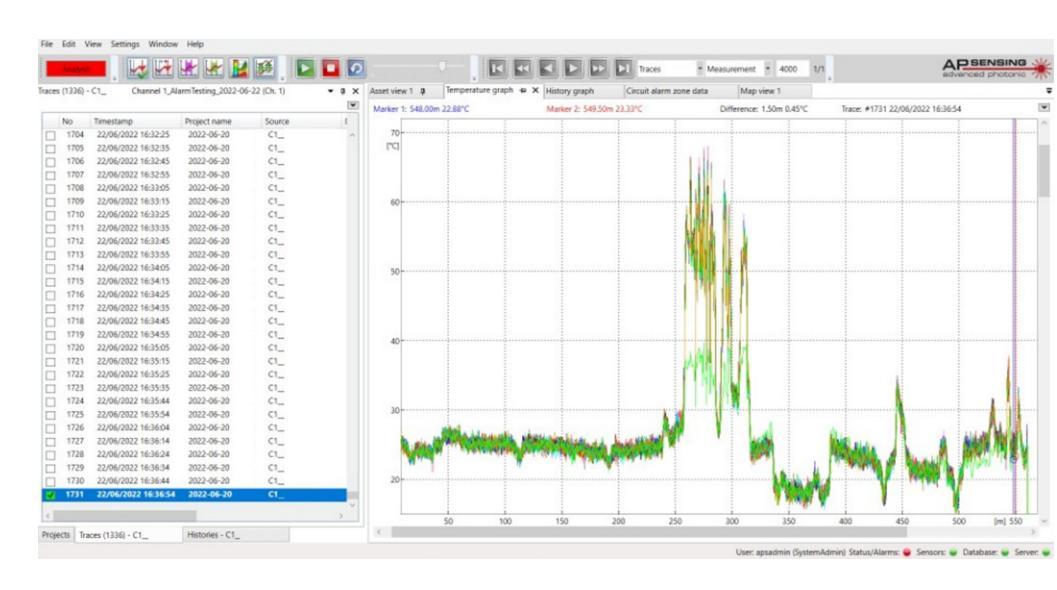
Temperature Profile of Bus Duct Infrastructure

After commissioning our DTS solution, the entire bus duct infrastructure was stress tested, meaning the electrical load on the bus duct was increased in a controlled manner. These tests were observed in real time by the end client's Operation Center and the system registered a maximum temperature value on the entire bus duct infrastructure that was still lower that the limits set by the manufacturer's certification (IEC 61439-6 Temperature-Rise).
